175 Bonita Avenue

1-800-900-1239**www.inspectiongroup.com****PROPERTY INSPECTION****Inspection Address:** 175 Bonita Avenue**Report Number:****Inspection City:** Redwood City**Inspection Date:** February 20, 2009**Client's First Name:** Alice**Last:** Elliott**Listing Inspection:** (Fee due within 90 days)**Agent's First Name:** Isaac**Last:** Malek**Phone:** (408) 725-2900**Ext:****Office:** Intero Real Estate**Fax:****Inspector:** TROY C. HARRISON**www.TheReportOnline.com Report password:** N/A**PRELIMINARY COMMENTS**

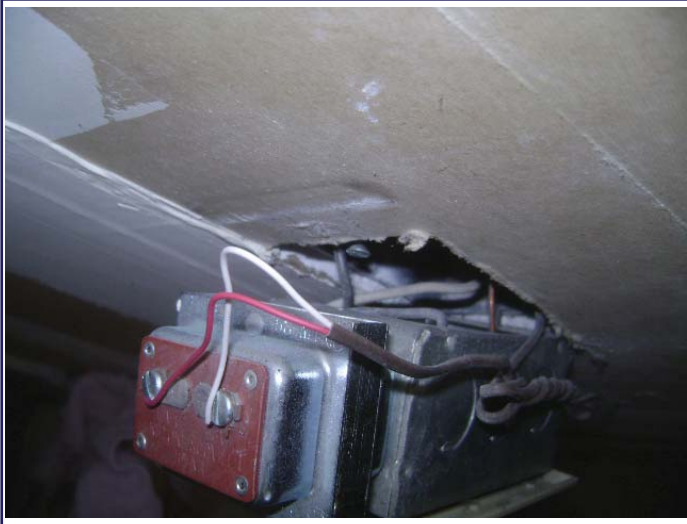
Photo 1

2) The electrical outlet/box in the garage, located behind the refrigerator is loose. For safety, I recommend having this corrected. All electrical wiring in the garage area below 7' feet needs to be installed in rigid conduit or protectively covered to prevent possible accidental contact from occurring. Consult with a licensed electrician for further evaluation of the electrical system and corrective repairs as needed.

Exposed electrical wiring (loose box) in the garage at the firewall

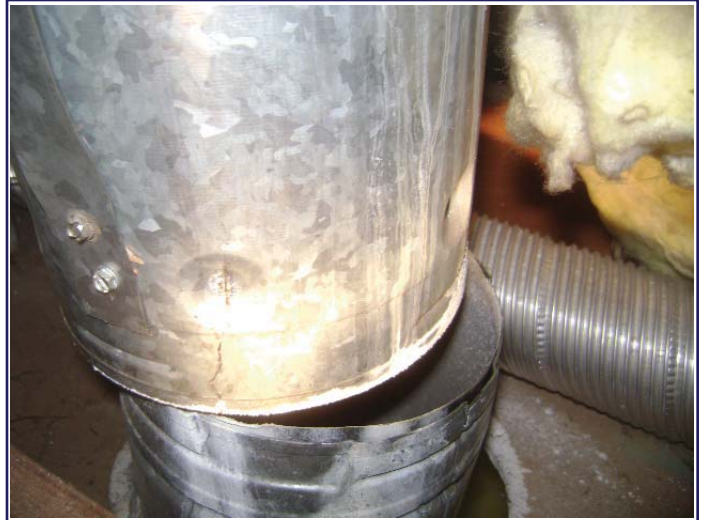
Photo 2

Furnace's flue pipe is disconnected in the attic

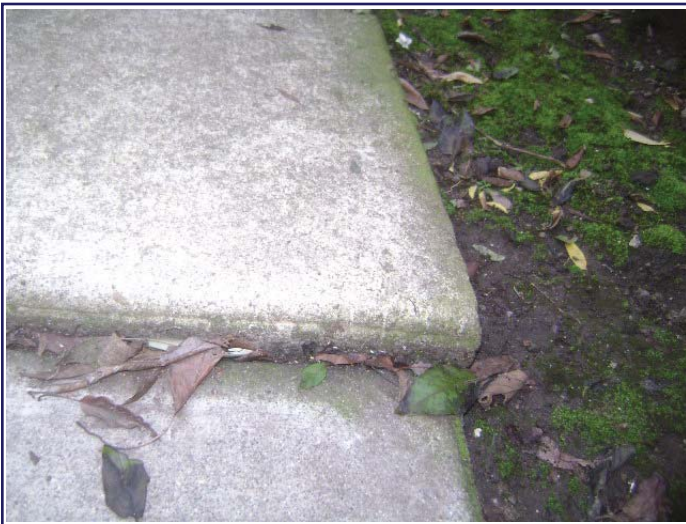
Photo 3

1) There was heaving to sections of the driveway and concrete walk on the right rear side of the house. It is recommended to have this repaired, as this may create a potential tripping hazard. In addition, fill any cracks in the driveway and walks to seal them from moisture and help protect the installations from damage. Consult with a qualified contractor for more extensive corrective recommendations and repairs. 2) There was a 1/2" inch+/- gap between the concrete walk and around the right rear side of the house. I recommend having this sealed, to prevent possible moisture intrusion from occurring. Consult with the appropriate contractor for further evaluation and corrective repairs. Note: Trim back any overhanging tree branches from the roof area and clean debris from the interior of the gutters, and install downspout extensions (if applicable) for proper drainage control of the roof run-off water. In addition, control the site moisture through proper control of the roof runoff water, correct grading, and by limiting unnecessary irrigation.

Heaving to a section of the concrete walk, located on the right rear side of the house

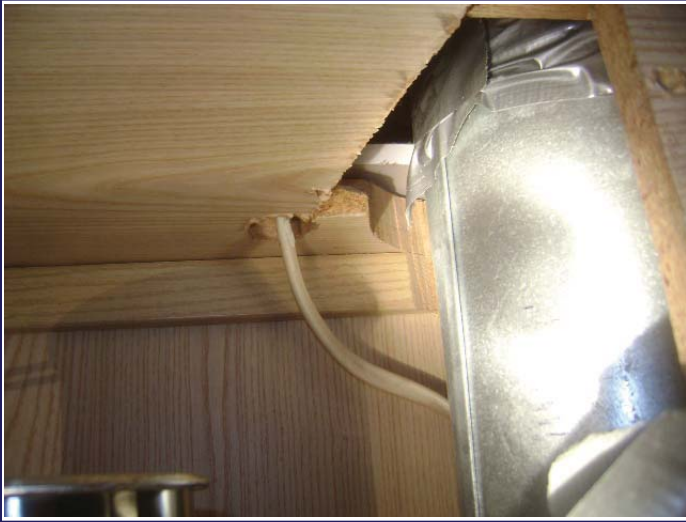
PHOTO PAGE II

3) There was unprotected electrical wiring observed in the cabinet above the stove. For safety, all electrical wiring in habitable areas needs to be protectively covered or concealed in wall space, to prevent accidental contact or mechanical damage from occurring.

Unprotected electrical wiring in the kitchen cabinet above the stove

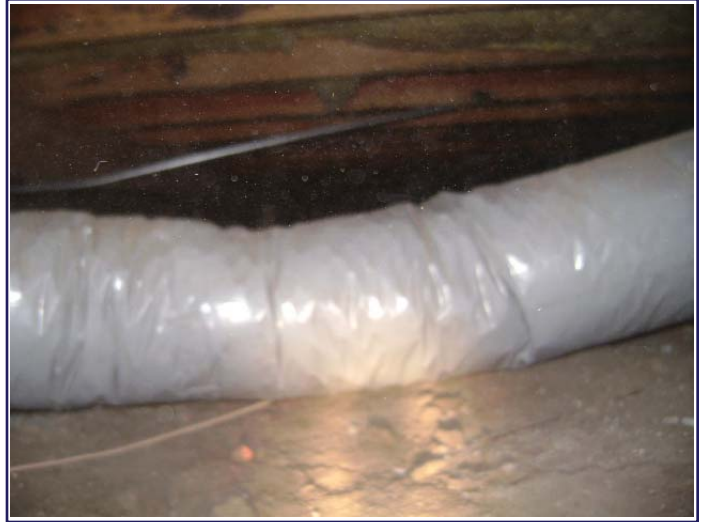
Photo 6

Heat duct in the sub area in contact with the soil

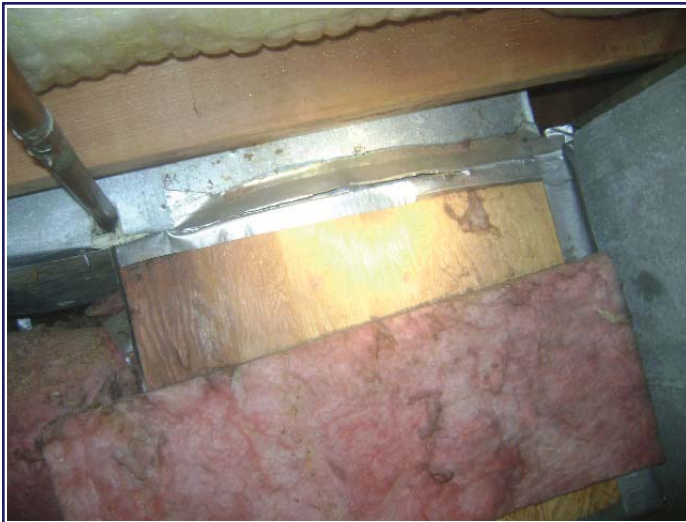
Photo 7

Plywood covering the side of the sheetmetal plenum in the sub area

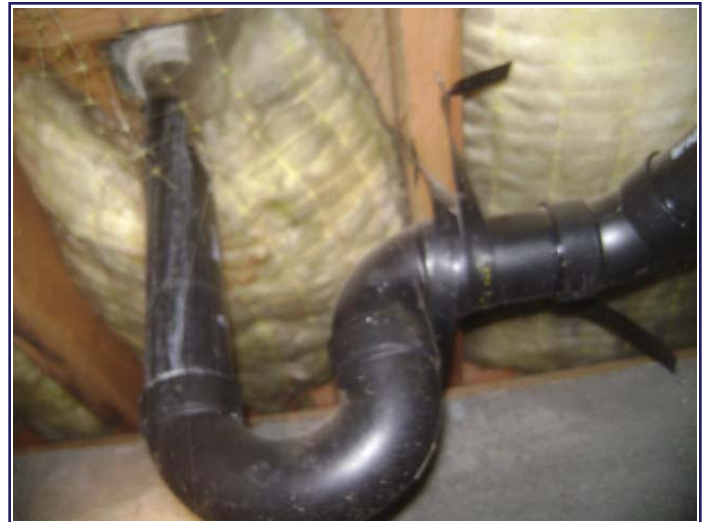
Photo 8

1) There was leakage observed from the drain line in the sub area below the shower enclosure, located in the lower level bathroom. I recommend having this corrected, to prevent possible damage from occurring. Consult with a licensed plumber for further evaluation of the plumbing system and to perform repairs as needed.

Leakage from the drain line below the shower enclosure in the lower level bathroom
